BUREAU OF SHIPS GROUP TECHNICAL INSPECTION REPORT

U.S.S. CORTLAND (APA75)

TECHNICAL INSPECTION REPORT

OVERALL SUMMARY

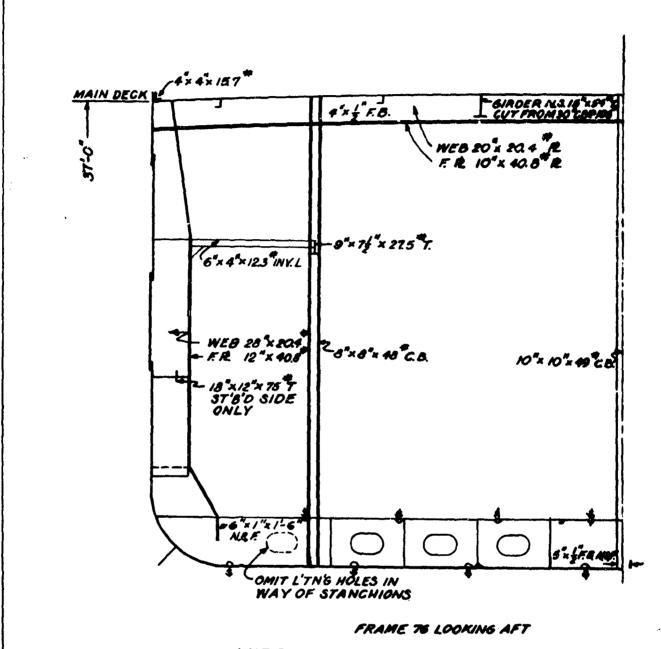
MIDSHIP

SECTION

TEST B

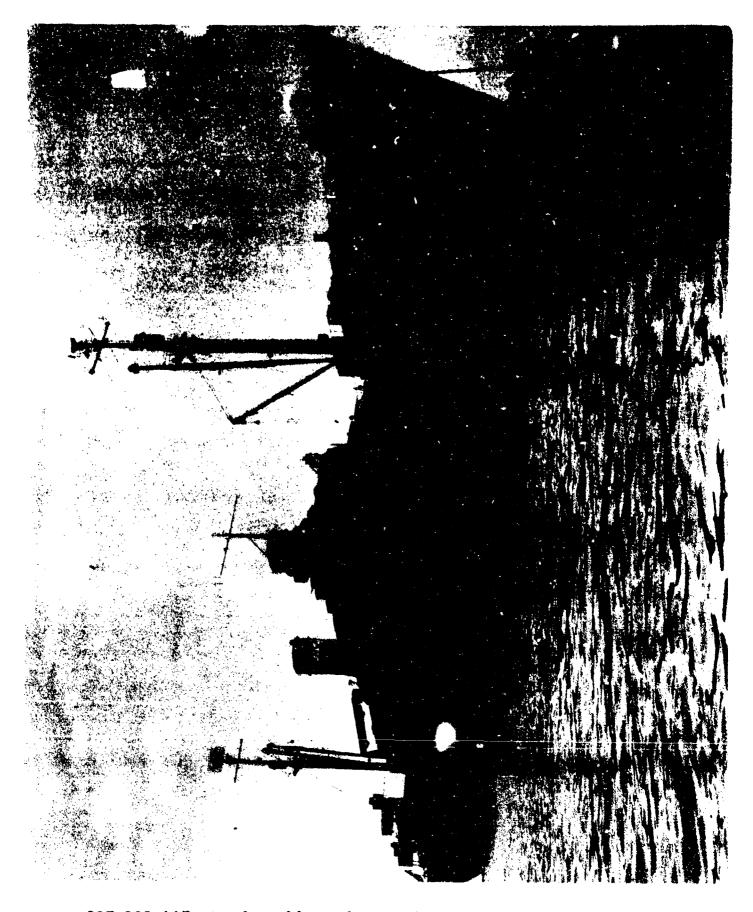
AA-CR-227-283-117. Starboard bow after Test B.
